March 2003 Denver Blizzard - A Retrospective PART I: Building Damage Due to Snow Loading

Greg G Gillmor, M.S., P.E., M.ASCE¹

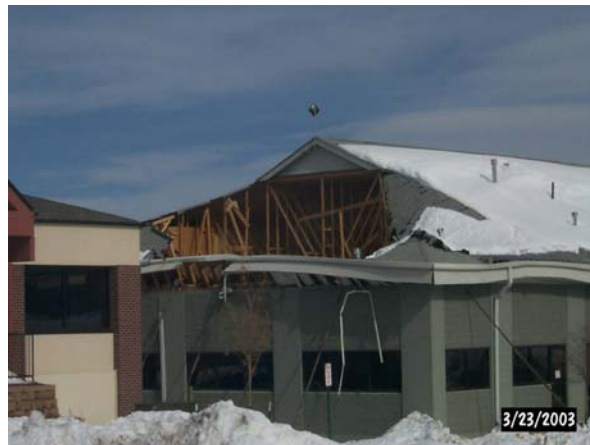
Photo 1. Collapsed roof due to snow load.

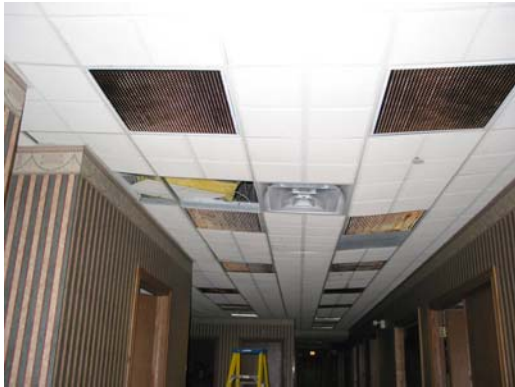
Photo 2. Deflection of suspended ceiling system.

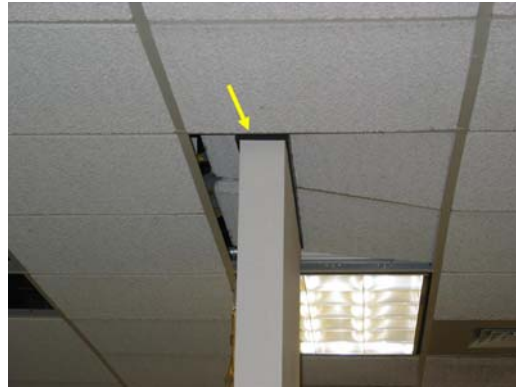
Photo 3. Incompatible deflection of ceiling system at partition wall.

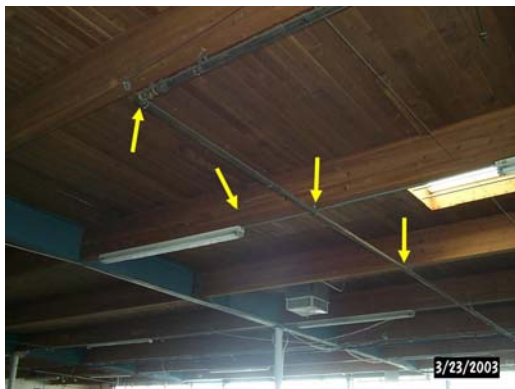
Photo 4. Utility line endangered by damaged roof beam.

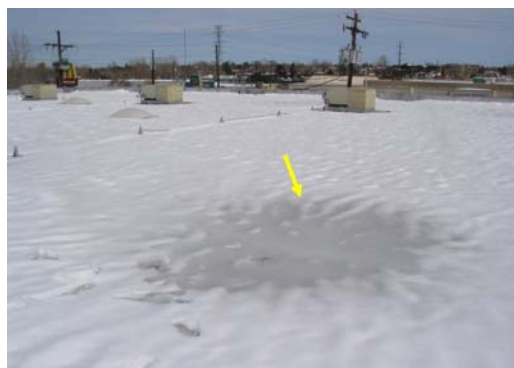
Photo 5. Ponded water on warehouse roof.

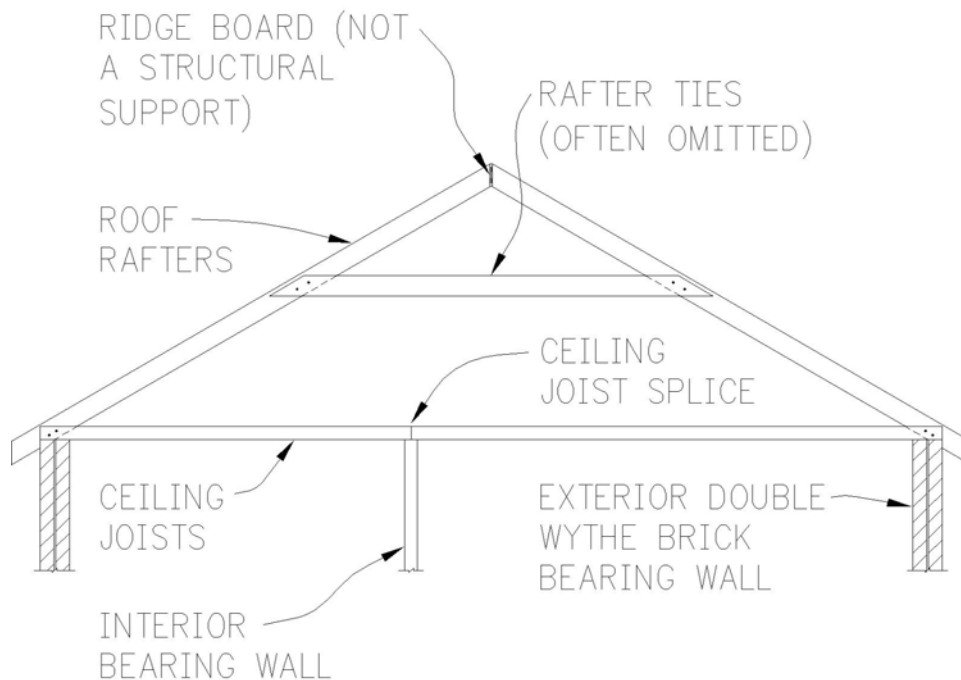
Figure 1. Typical “Denver Bungalow” stick-framed construction.

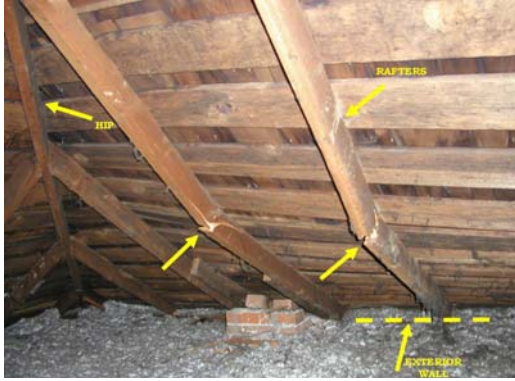
Photo 6. Cracked roof rafters in a Denver Bungalow.

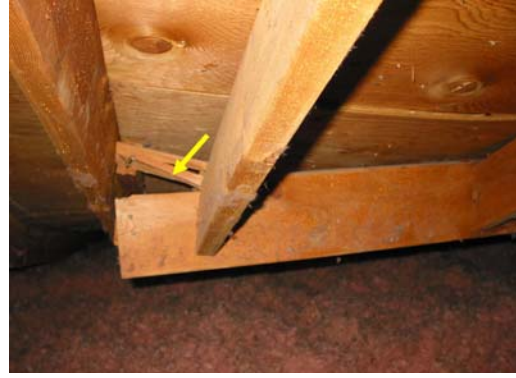
Photo 7. Damaged roof connection of a Denver Bungalow.

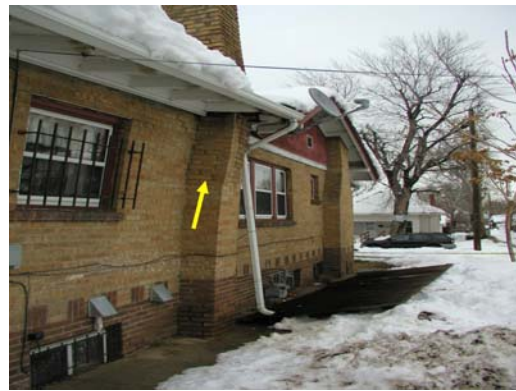
Photo 8. Leaning brick on exterior wall of a house due to outward roof thrust.

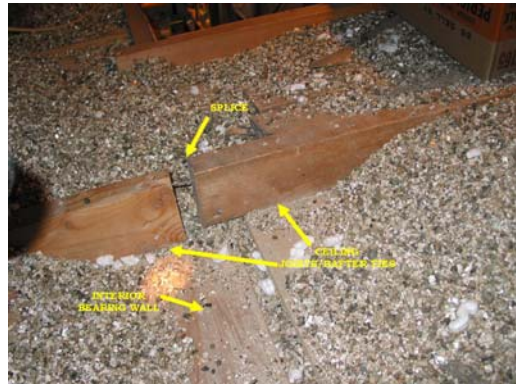
Photo 12. Splice of ceiling joists being pulled apart by outward roof thrust.

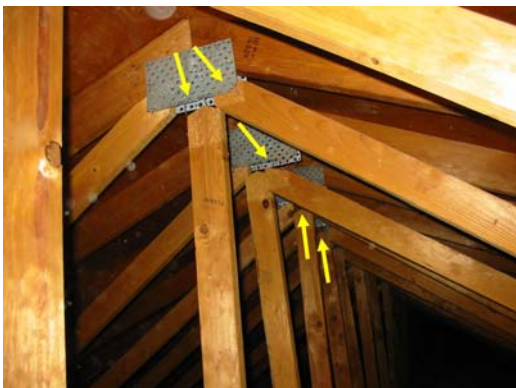
Photo 13. Truss web pull-out from press plate at panel point connection.

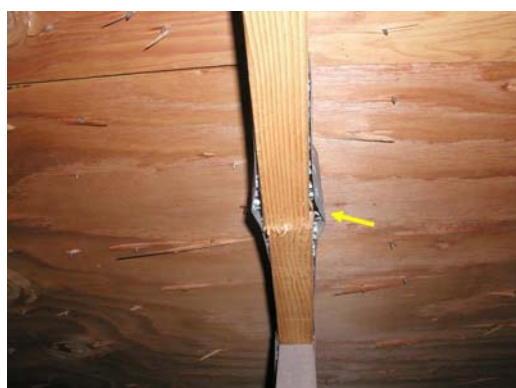
Photo 14. Buckled metal plates at truss top chord splice.

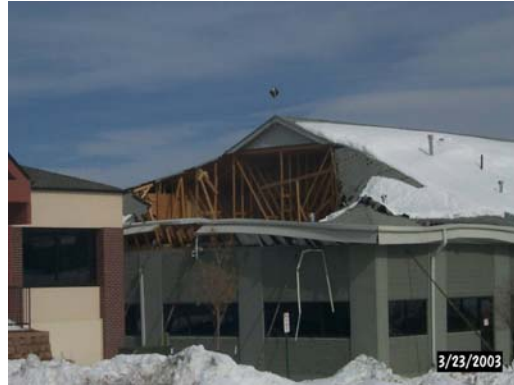
Photo 15. Collapsed roof due to snow load.

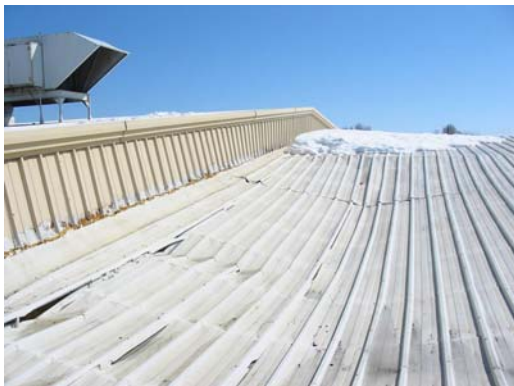
Photo 17. Failed roof over metal z-purlin supports.

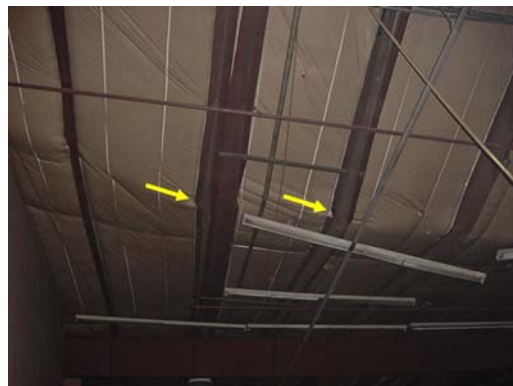
Photo 18. Failed roof - metal z-purlins rotated and buckled.

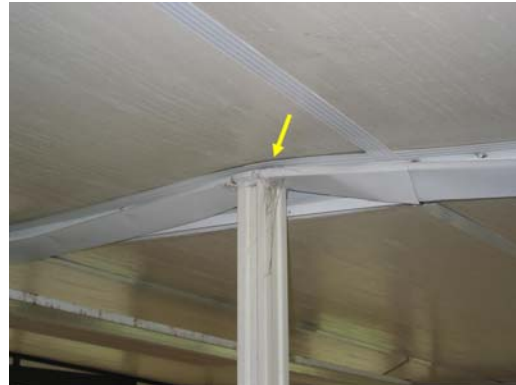
Photo 19. Crushed roof beam on prefabricated metal building.

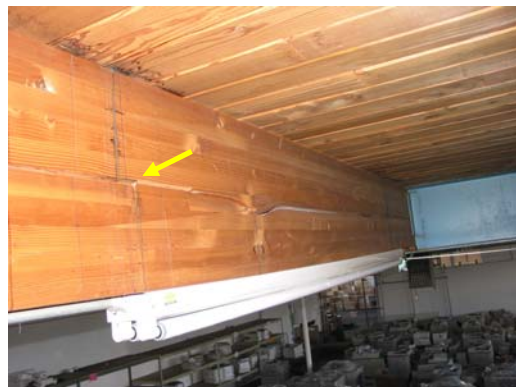
Photo 20. Shear crack parallel to grain in glued laminated timber beam.

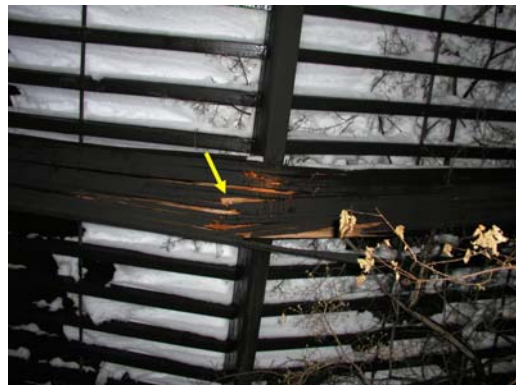
Photo 21. Failed trellis roof structure due to snow "bridging" the gaps between roof members.

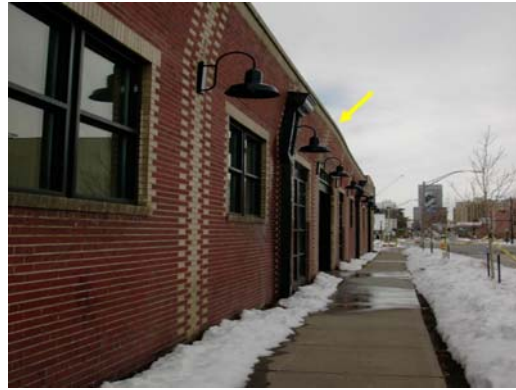
Photo 22. Parapet wall bowing outward under lateral forces from snow build-up behind the wall.

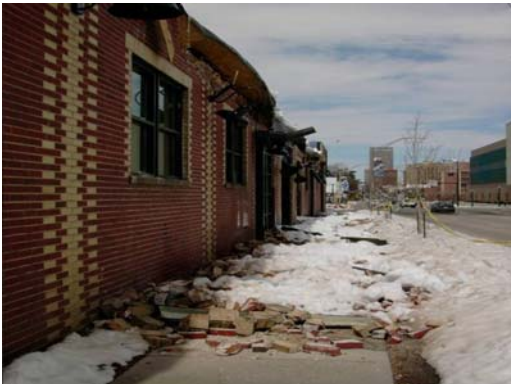
Photo 23. Failure of a section of parapet wall.

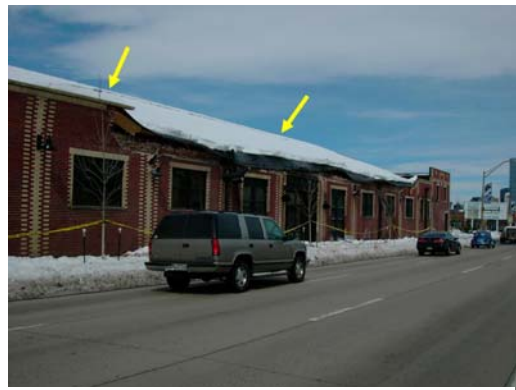
Photo 24. Photograph showing extent of damaged parapet and break line of snow slide.

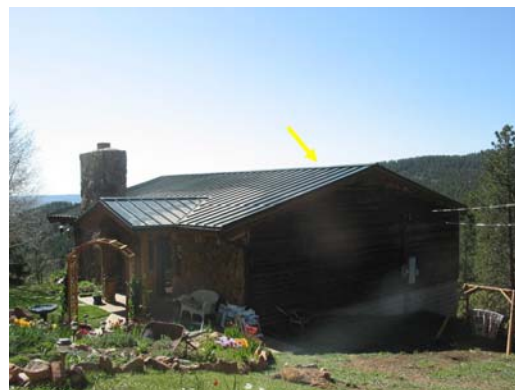
Photo 25. House with standing seam metal roof and no snow guards.

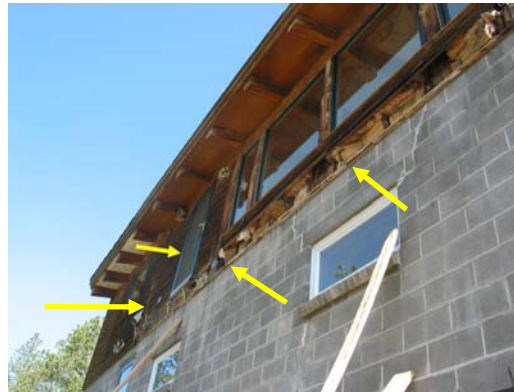
Photo 26. The deck on the back side of this house collapsed under the impact of sliding snow.

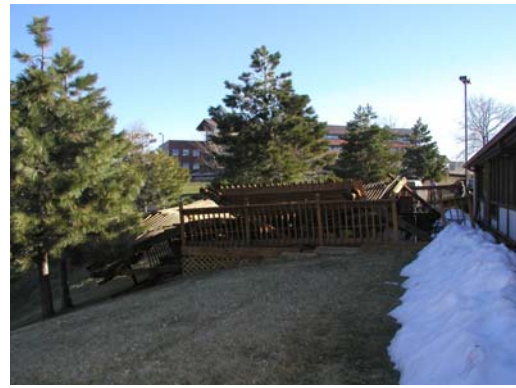
Photo 27. Lateral collapse of trellis structure due to sliding snow.

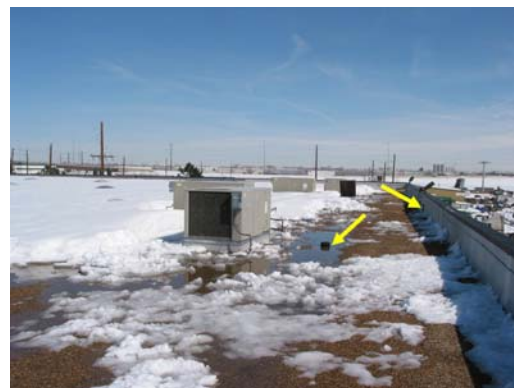
Photo 28. Drainage on concrete double-tee roof.

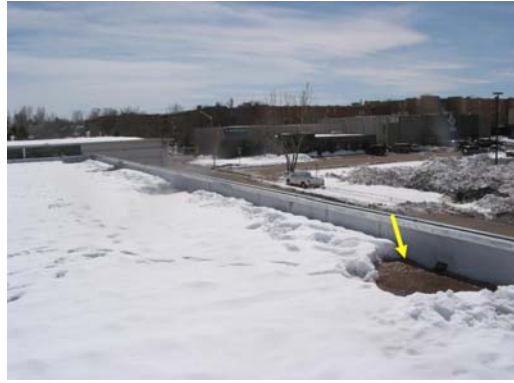
Photo 29. Clearing of roof drains to promote efficient drainage.
